## **Chapter 4-4: Fire Endurance Performance of Operation Breakthrough Assemblies**

## Chapter 4-5: Fire Endurance Performance of Coatings

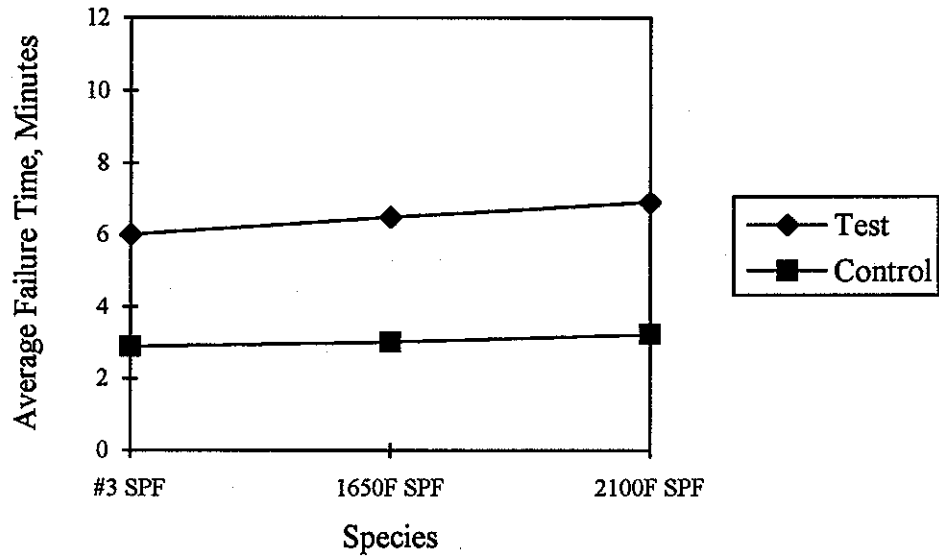
Figure 31. Average Failure Time for Horizontal Specimens

Number Specimens Tested	Average Failure Time (min.)	Ratio Test Over Control (%)
<b>Horizontal Placement (3.5" Face) Over Flame</b>			
#3 SPF Control	10	2.88	
#3 SPF Test	10	6.00	208
1650F SPF Control	10	3.00	
1650F SPF Test	10	6.47	216
2100F SPF Control	10	3.22	
2100 F SPF Test	10	6.88	214
<b>Vertical Placement (1.5" Face) Over Flame</b>			
#3 SPF Control	10	4.04	
#3 SPF Test	10	7.08	175
1650F SPF Control	10	4.65	
1650F SPF Test	10	8.67	186
2100F SPF Control	10	5.83	
2100 F SPF Test	10	11.27	193
<b>Total Specimens Tested</b>	<b>120</b>

These data from the table above are represented graphically in Figures 31 and 32:

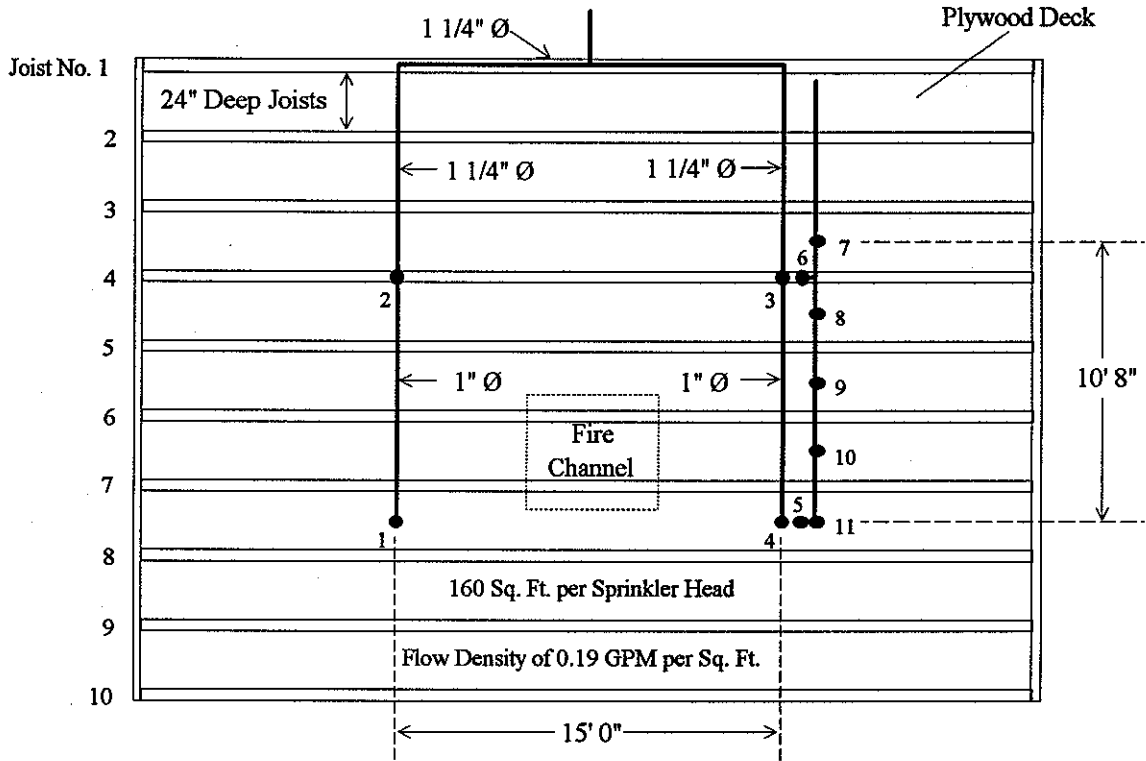
Figure 37. Diagram of Test 2.

**Test 2:** The second fire test was the same as the first, except that the spacing of the branch lines was at 15 ft., and active sprinkler heads were 10 ft., 8 in. apart. This represented the maximum spacing allowed (130 ft.<sup>2</sup> per head) in NFPA13 for ordinary hazard occupancies. ('Ordinary' indicates certain construction types and combustible contents using lightweight engineered construction.)

The response time of the charged sprinklers in this test was approximately 3 min., 26 sec. into the test--one minute longer than the response times of the charged sprinklers in Test 1. However, the charged sprinklers in Test 2 were located approximately 50 percent further away from the fire. At approximately 4 min. from activation of the two standard response sprinklers, the fire in the floor assembly had been completely extinguished. At 4 min., 30 sec., flames were confined to the wood crib. By 8 min., 30 sec., the fire was completely out, and the test concluded. Damage to the floor assembly was similar to that observed in Test 1. Charring of approximately 1/16 and 1/8 in. was observed on the I-joists and the exposed surface of the deck on the portion of the joist channel which was located directly over the wood crib. Some charring was noted beyond this area, but was limited to surface charring. Minor discoloration was also noted.

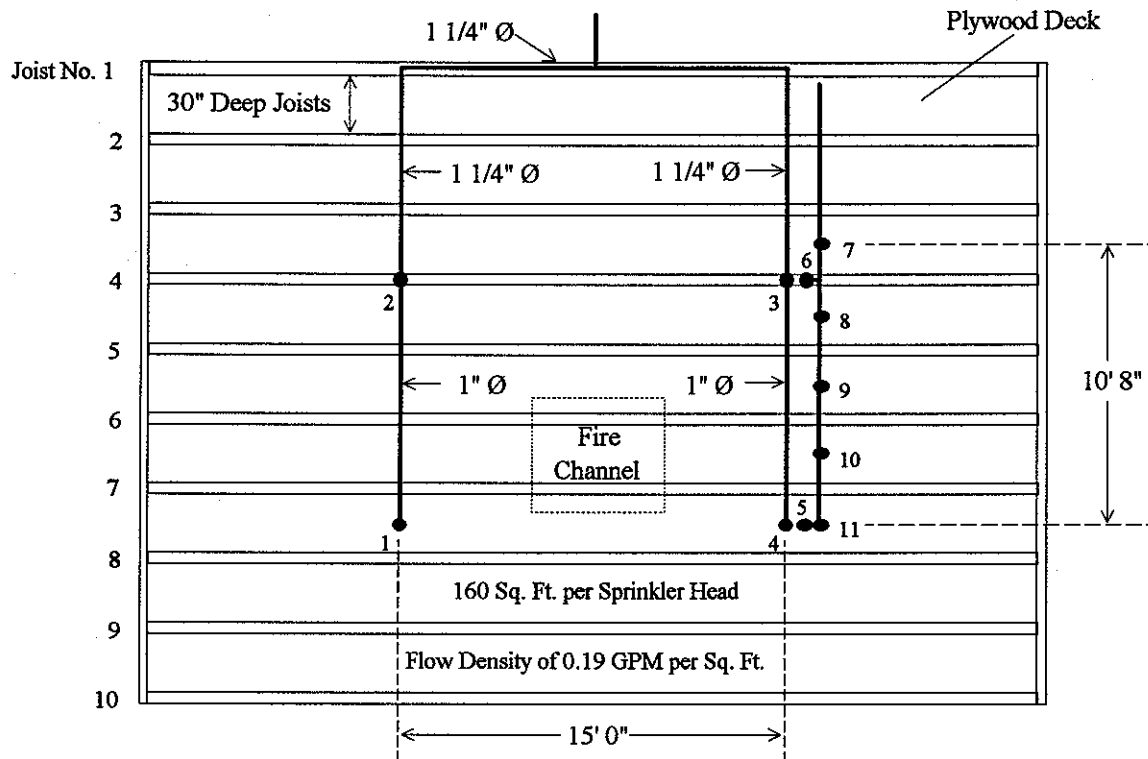
Figure 38. Diagram of Test 3.

**Test 3:** This test was identical to the second, except that the effective joist depth was increased to 30 in. All active sprinkler heads were centered between the joists, with deflectors positioned 31 in. beneath the deck.

Two charged standard response sprinklers activated at 4 min., 10 sec. and 4 min., 11 sec. into the test. These were soon followed by two more activations at 4 min., 15 sec. and 4 min., 21 sec., respectively. At 4 min., 31 sec., all fire in the floor assembly had been extinguished. At 13 min., 56 sec., the fire in the wood crib was completely out, and the test concluded. Damage to the floor assembly during Test 3 was minimal, and confined to that portion of the joist channel located directly above the wood crib. Damage to the assembly beyond the central portion of this channel was limited to surface discoloration.

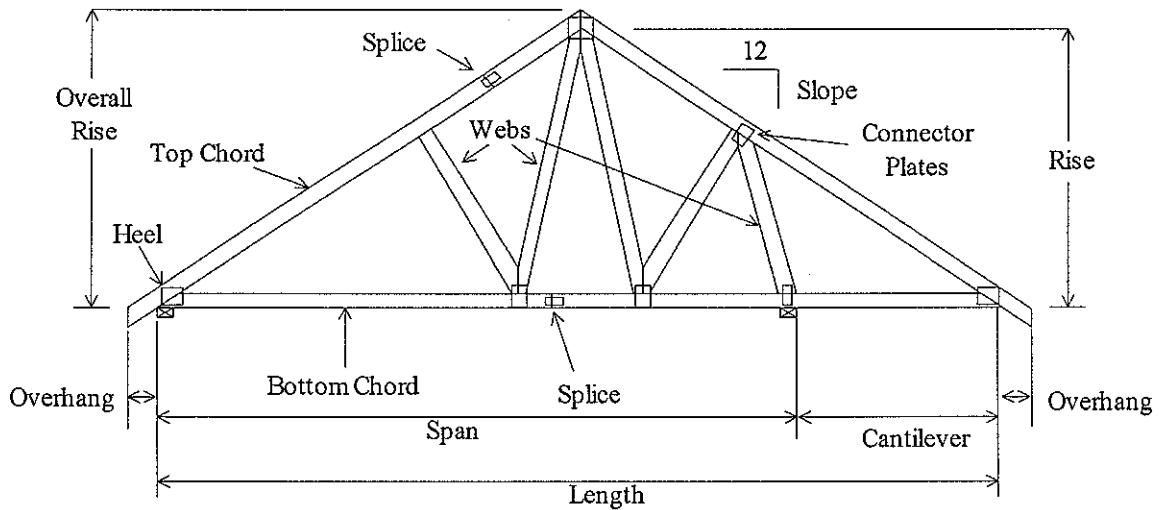
**Web members**, n - dimension lumber members that form the interior members of the truss.  
(See figure below.)

**Pitched chord truss**, n - the top chord singly or the top and bottom chords together slope to provide a surface that is at some angle to the horizontal plane. (See figure below.)
